EARTHQUAKE ENGINEERING RESEARCH LABORATORY

**ANALYSIS OF SIMULTANEOUS OPERATIONAL FAILURE
OF CRITICAL FACILITIES DUE TO EARTHQUAKE, FOR A
CALIFORNIA UTILITY**

**KEITH A. PORTER
SWAMINATHAN KRISHNAN
XIN XU**

REPORT No. EERL 2006-01

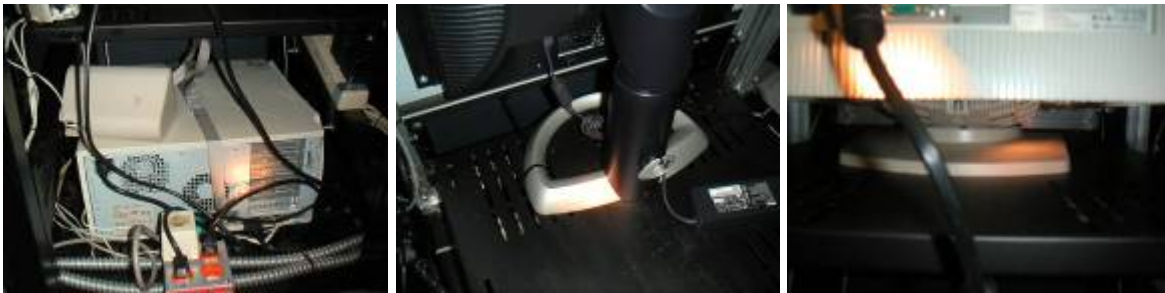
Some of the computer monitors and system units (the boxes that house the disk drives, system board, central processing unit, etc.) in the consoles were observed to be restrained against sliding, and some appeared to be unrestrained (Figure 3-5). Lack of restraint tends to increase the probability that the component will slide, overturn, and possibly cease to operate in the event of an earthquake. Unrestrained computers and monitors could be a weak link at this facility. The large display board contains a number of liquid crystal displays, which appeared to be well secured to a Unistrut steel frame, itself apparently anchored to the floor and wall (Figure 3-6).

Figure 3-5. Some but not all computer equipment in grid control room appeared to be restrained

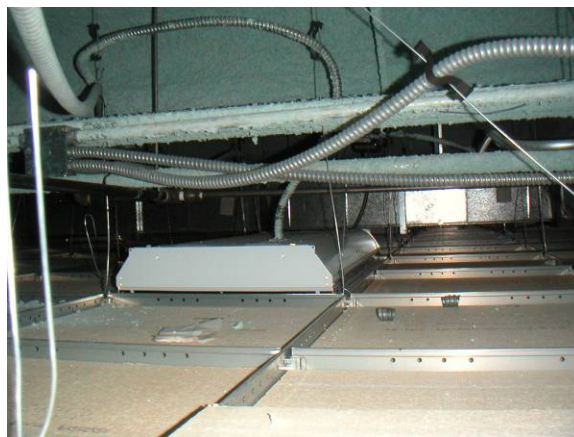
appeared to lack safety wires secured to the slab above (Figure 3-11). This is primarily a life safety hazard, although in the 1983 Coalinga earthquake, falling light fixtures caused damage to equipment below (EQE Inc., 1986). The room is protected by a Halon system for fire suppression, and the Halon tank is secured to the wall (Figure 3-12).

Figure 3-11. Some light fixtures in the main computer room appeared to lack safety wires

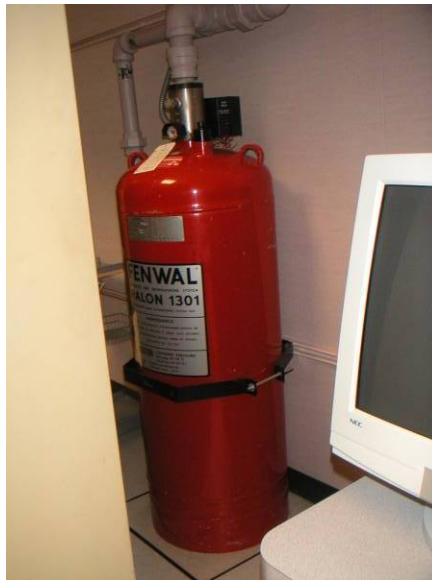
Figure 3-12. Halon tank in main computer room appeared to be secured to the wall

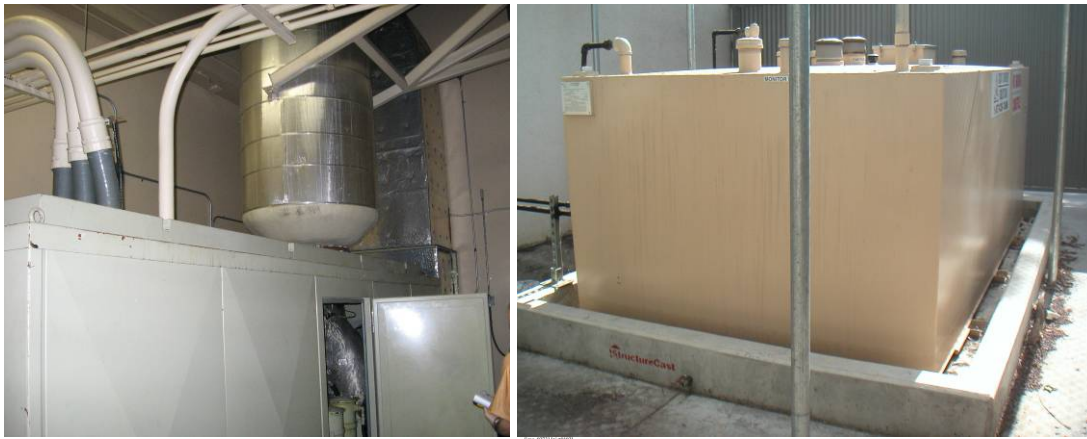
Standby emergency generator. A 800 kW Saturn Solar generator is installed at the facility, which we were told is of powering the entire GCF. It is supplied from a 2000-gallon tank outside the building (Figure 3-13), which is anchored to the slab, and capable of supplying the generator with 50 hr of fuel at 40 gal/hr. However, the fuel is delivered to the generator via a combined day tank and fuel pump (Figure 3-14). The fuel pump and day tank are not secured to the floor, which substantially increases the probability that in a strong earthquake they would slide and break the attached piping, itself secured to the wall, rendering the generator inoperative and possibly spilling diesel fuel (Figure 3-15). The generator requires batteries to power its starter motor. Although the battery rack is secured to the floor, the batteries lack spacers to prevent them from sliding within the rack (Figure 3-16), which increases the probability that movement of the batteries would break the conductors between individual cells, which would prevent the batteries from powering the starter motor, and prevent from the generator from starting. The generator is tested monthly, a desirable feature that mitigates the probability of operator failure or undetected equipment damage. However, the day tank's lack of anchorage and the battery rack's lack of spacers appear to be important weak links in the GCF's provision for on-site electric power in the event of the loss of off-site power.

Figure 3-13. GCF emergency generator (left) and its fuel tank (right)

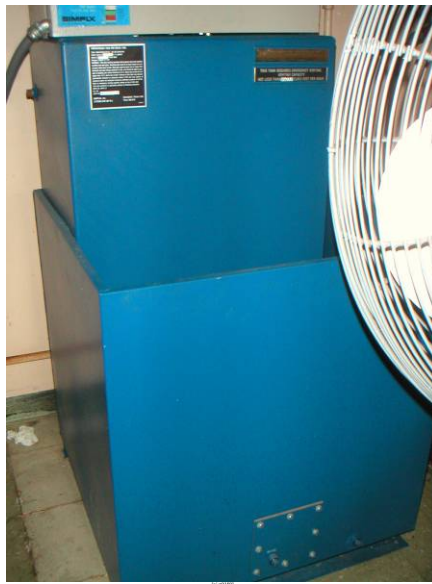
Figure 3-14. GCF combined generator day tank and fuel pump, apparently not anchored to the slab

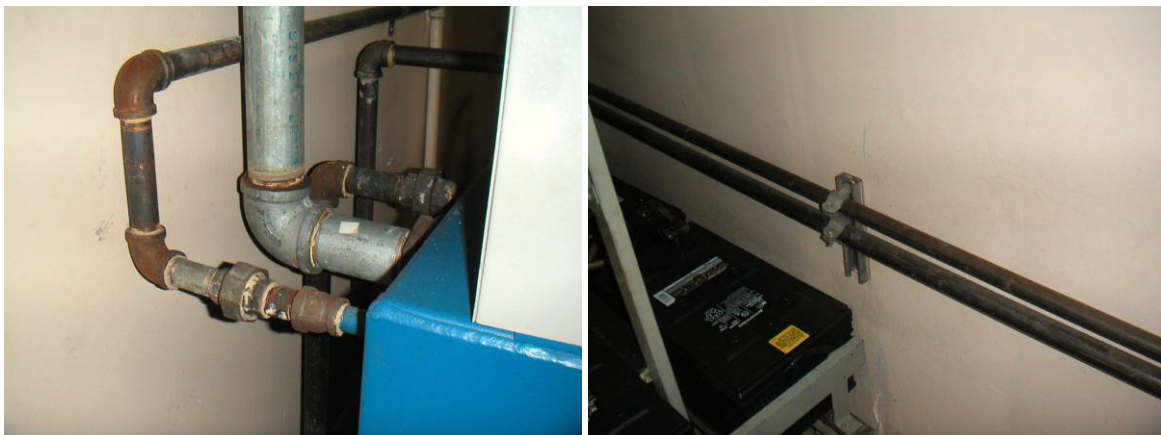
Figure 3-15. Piping attached to GCF generator day tank

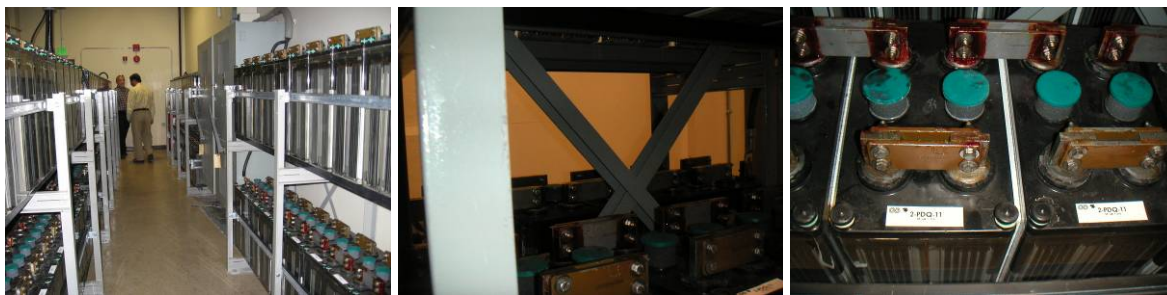
Other electrical equipment in electrical building. Uninterruptible power supply (UPS) equipment and other electrical equipment are housed in a small structure adjacent to the main building. The UPS battery racks are well anchored to the floor slab, have longitudinal diagonal braces and batteries are restrained from falling off the rack and supplied with spacers between batteries, all desirable features (Figure 3-17). Cabinets holding the transfer switches, as well as all other controls, breakers, and transformers whose anchorage was examined, appeared to be anchored to the floor slab (Figure 3-18). While overhead cable trays in at least one portion lacks lateral restraint, the run is braced in each direction by an abutting wall (Figure 3-19). There are some pendant lights in this room of a type that have collapsed in past earthquakes, but again, this mostly life-safety concern is mitigated by the fact that the room is not normally occupied (Figure 3-19). A radio tower on the top of this electrical building was not examined for seismic resistance (Figure 3-20).

Figure 3-17. GCF battery racks

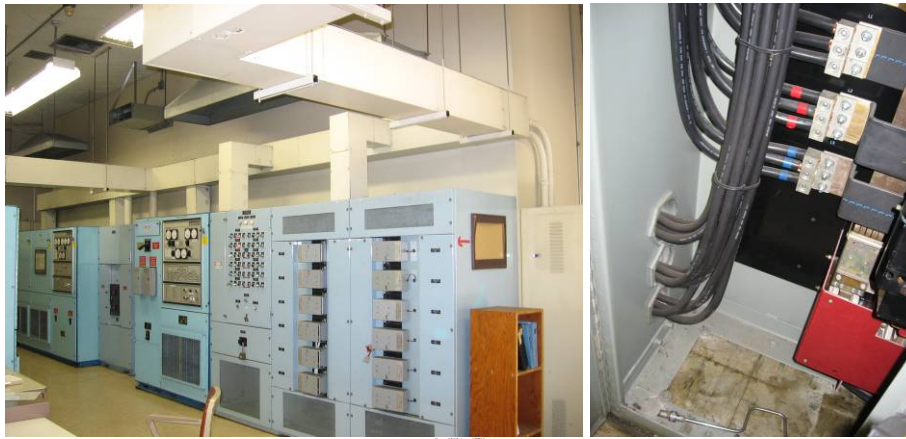
Figure 3-18. Electrical cabinets appeared to be anchored to floor slab

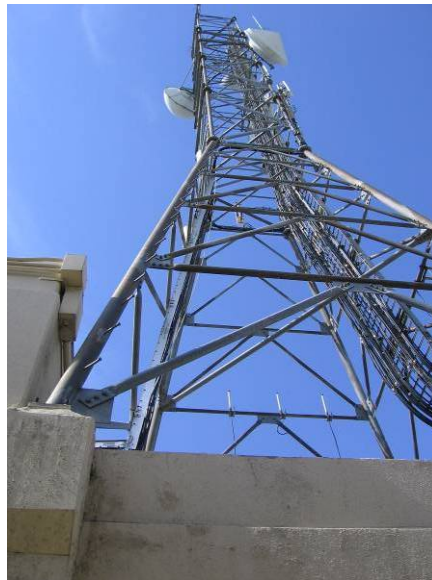
Figure 3-20. Radio tower at GCF

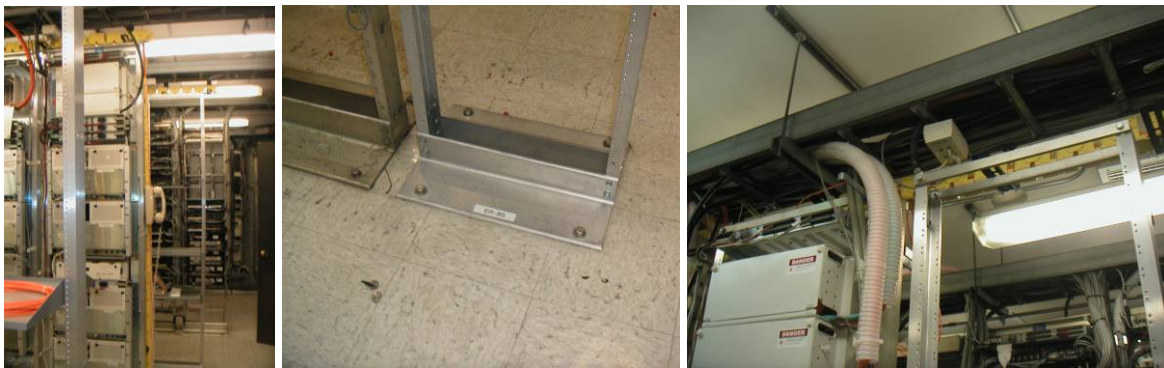
Telephone switching equipment. Telephone switching equipment in the telecommunications room appeared to be anchored at the base although without apparent bracing at the top (Figure 3-21). Cable trays lacked sway bracing, but were generally not in long straight runs, and did not appear to be particularly heavily loaded or capable of falling off their supports (Figure 3-22).

Figure 3-21. Anchorage of DPF telephone switching equipment

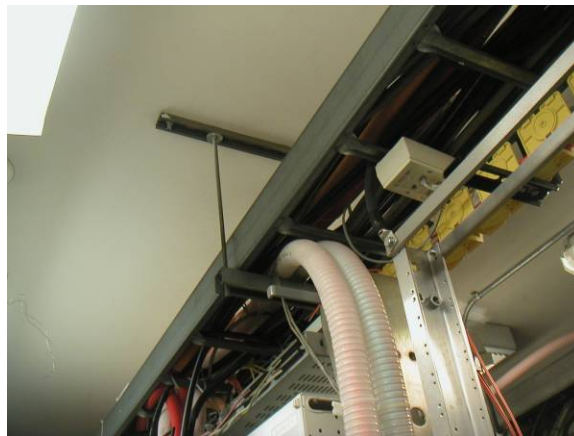
Figure 3-22. A DPF cable tray in a telephone switch room

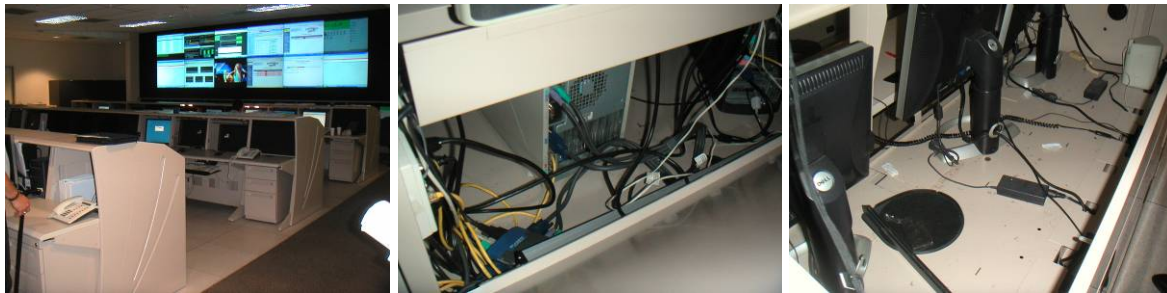
Information Technology Operations Center (ITOC). Computer equipment in this room is mounted in long consoles, largely without straps or other means of preventing sliding or overturning of the system units or monitors (Figure 3-23). There appears to be no restraint of the consoles themselves to prevent sliding or overturning. Other furnishings in the room such as tall filing cabinets lack seismic restraint (Figure 3-24). Raised access floor in this room is on heavy 2-ft pedestals, but each pedestal appeared to be secured to the slab below by two

Figure 3-23. Consoles containing apparently unrestrained computer system units and monitors

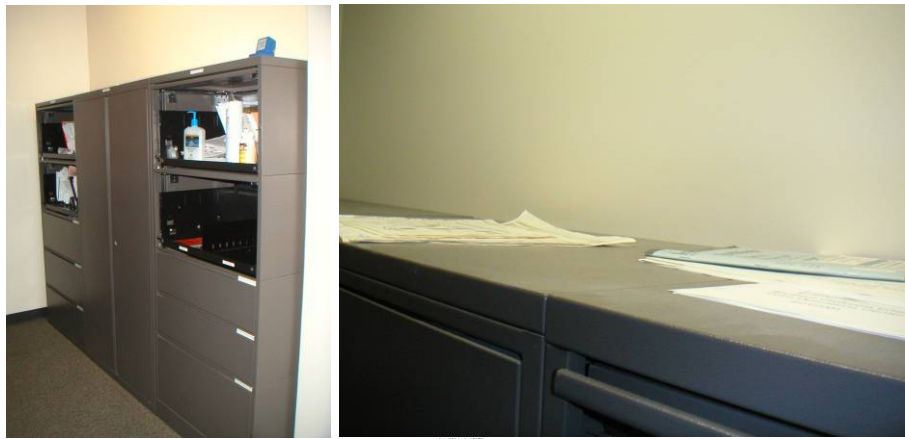
Figure 3-24. Apparently unrestrained tall furnishings in DPF ITOC room

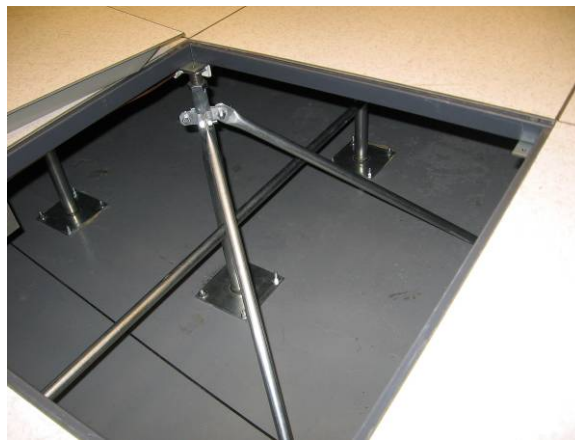
Figure 3-29. Bracing on raised access flooring in part of CPU room 2

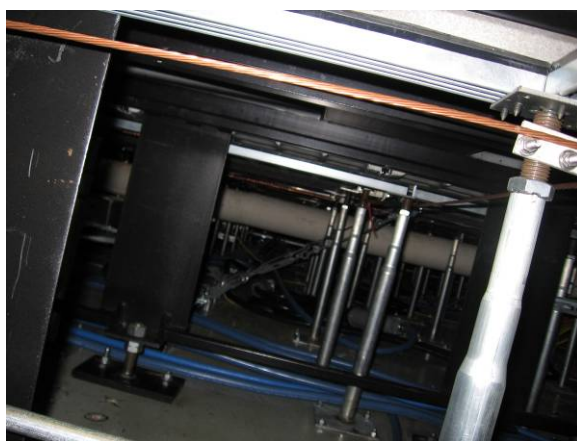
CPU rooms 1 and 2. Suspended ceilings examined here lack compression struts, and it was unclear whether light fixtures in the ceiling had secure, independent safety wires, which if absent would indicate a higher probability that light fixtures could fall, threatening life safety and endangering computer equipment. Computer equipment cabinets here are tethered at four corners to the slab below by various systems: slack steel cable with turnbuckles for tension adjustment, anchored to Unistrut members bolted to the slab below and secured by various means to the cabinet above (Figure 3-27); or by steel frames (Figure 3-28). Raised access floors in CPU room 2 are braced on one side of the room (Figure 3-29), although not on the other. Computer cabinets are all secured to the slab below by similar means as in CPU room 1, i.e., tethers or rigid frames, although it appears that the rigid frames in some cases rely on relatively long unbraced lengths of bolt (Figure 3-30).

Figure 3-30. Seismic restraint of equipment in CPU room 2

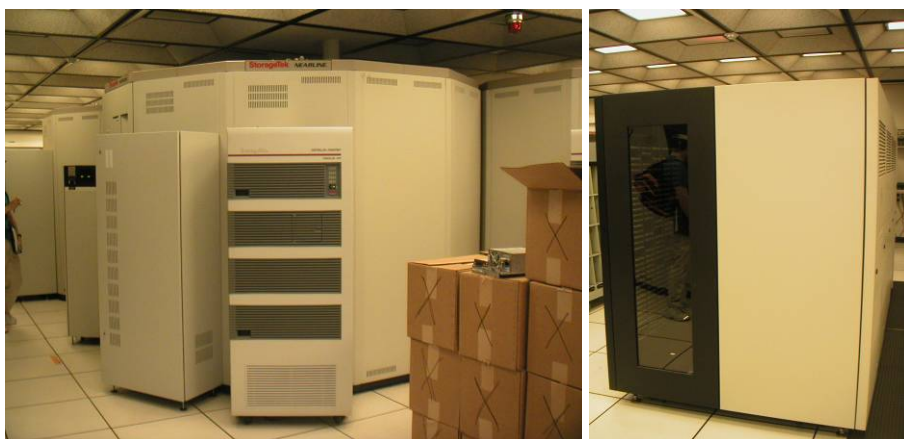
Tape library. This room houses five cylindrical tape silos³, as well as some smaller units that perform the same function (Figure 3-31). The tape silos are not secured to the floor, resting on leveling devices (Figure 3-32); in strong shaking, conduit attached to the tape silos from above (we were told these were for Halon supply; see the pipe above the cylindrical tape silo on Figure 3-31) would provide limited restraint, although these conduits are probably not intended to serve such a purpose. The raised access floors themselves lack diagonal bracing, and stand on slender pedestals secured to the slab with two shot anchors per pedestal (Figure 3-33). Halon tanks in this room are secured to the wall, and Halon pipes appeared to be at least partially braced (Figure 3-34). The lack of seismic restraint for the raised access floors and tape silos may represent a weak link at this facility.

Figure 3-31. Tape silos at DPF

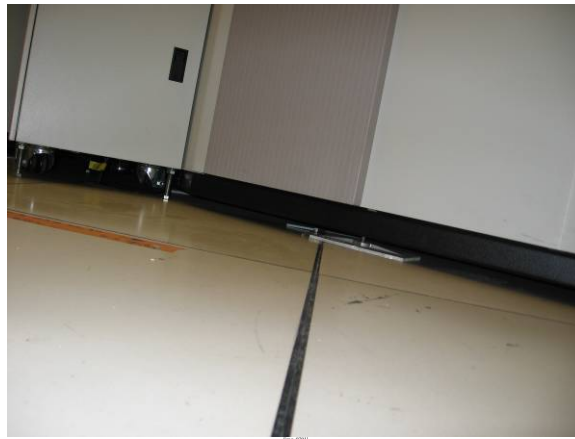
Figure 3-32. Levelers under DPF tape silo

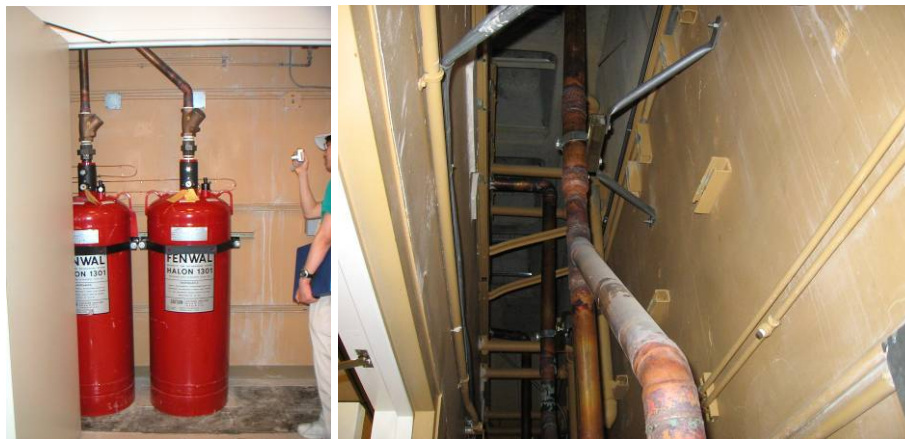
Figure 3-34. Halon tanks and pipe in DPF tape silo room

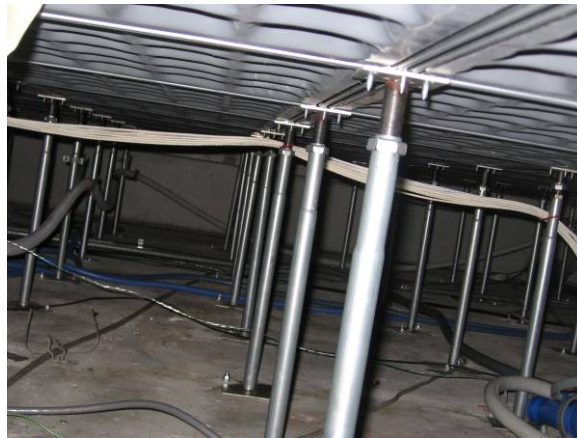
flooring without diagonal bracing and limited anchorage to the slab below (two anchors per pedestal, as opposed to four; Figure 3-36). The lack of seismic restraint for the raised access floors and printers seems to represent another weak link at this facility.

Figure 3-36. Apparently unbraced raised access floor in DPF printer room

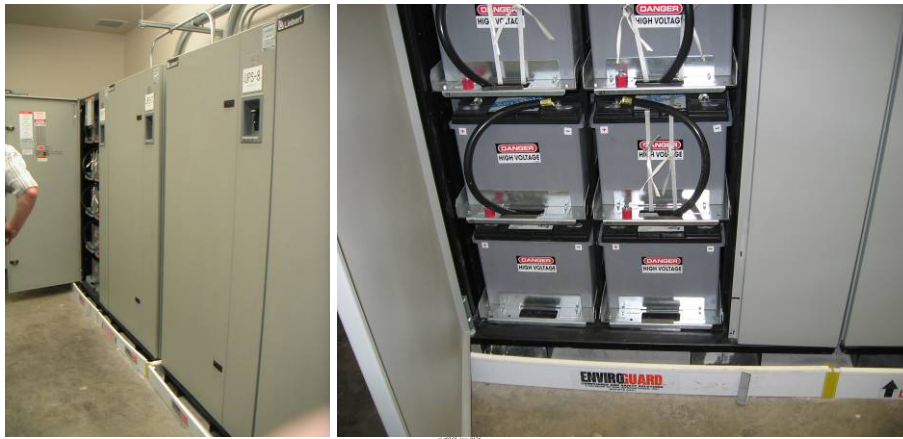
UPS equipment. The uninterruptible power supply (UPS) system, comprising two banks of two redundant systems (5 and 6, 7 and 8; Figure 3-37) appear to be anchored to the slab although not braced at the top (Figure 3-38); batteries appeared to be generally, but not always, secured on their racks, as shown in Figure 3-37. The cabinets that house the rectifiers, inverters, and other electric equipment needed to convert between outside power and UPS power appeared to be anchored to the slab (Figure 3-39). The electrical conduit between the batteries and these cabinets were supported on hangers that appeared to be braced to the wall (Figure 3-40).

Figure 3-37. DPF battery racks

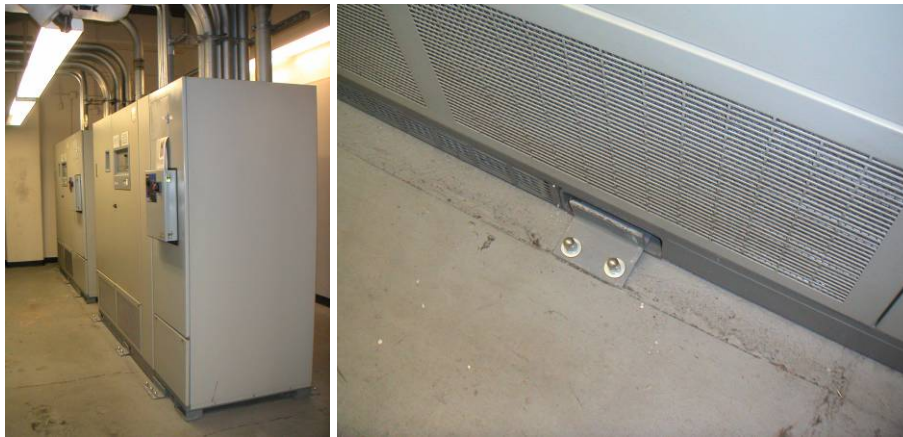
Figure 3-39. UPS cabinets appeared to be anchored

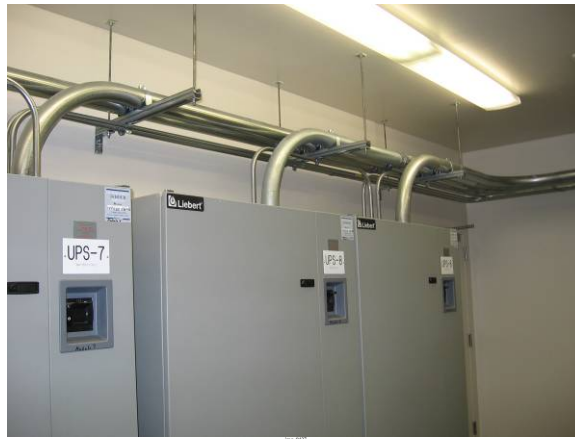
Figure 3-40. UPS electrical conduit hangers in DPF apparently braced to the wall

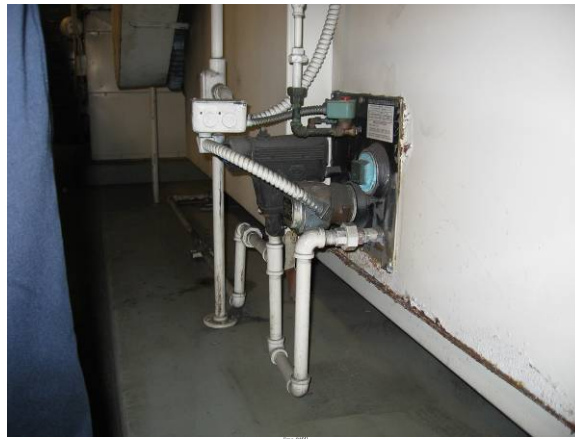
are on vibration isolators without seismic snubbers (Figure 3-42). (Seismic snubbers are metal fixtures attached to the slab next to a vibration-isolated mechanical device to restrain the device's lateral movement; an example is shown in Figure 3-43). The AHUs are rigidly attached to piping that could be damaged by excessive displacement of the AHU in an earthquake (Figure 3-44), which is another issue that tends to raise the probability of operational failure. Note that two of the four AHUs are needed. Lack of seismic restraint for these AHUs is a potential weak link at this facility.

Figure 3-44. Piping rigidly attached to an air handling unit in DPF

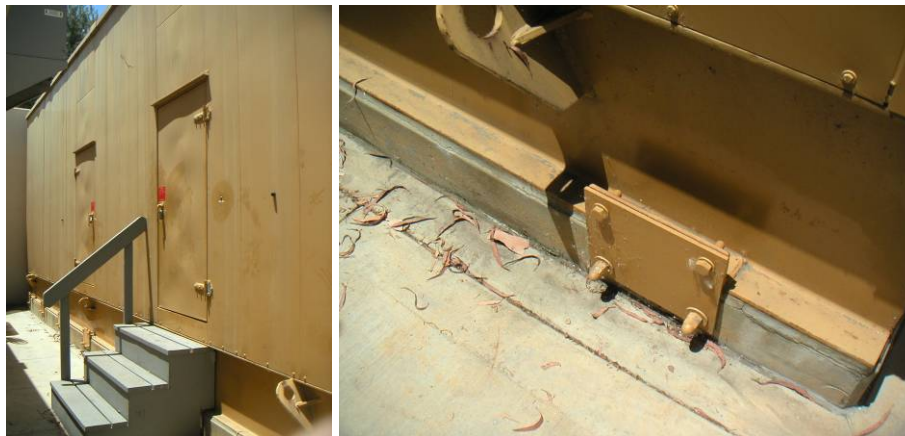
Emergency generator. A diesel generator is located outside the building within an unroofed enclosure. The generator has a belly tank and a 10,000 main fuel tank capable of supplying the facility with electric power for 4 to 8 days. The generator, its fuel tank, and switchgear appear to be well anchored (Figure 3-45, Figure 3-46, Figure 3-47). Other nearby switchgear and transformers (Figure 3-48) appeared to be anchored to the slab.

Figure 3-45. DPF generator and its seismic restraint

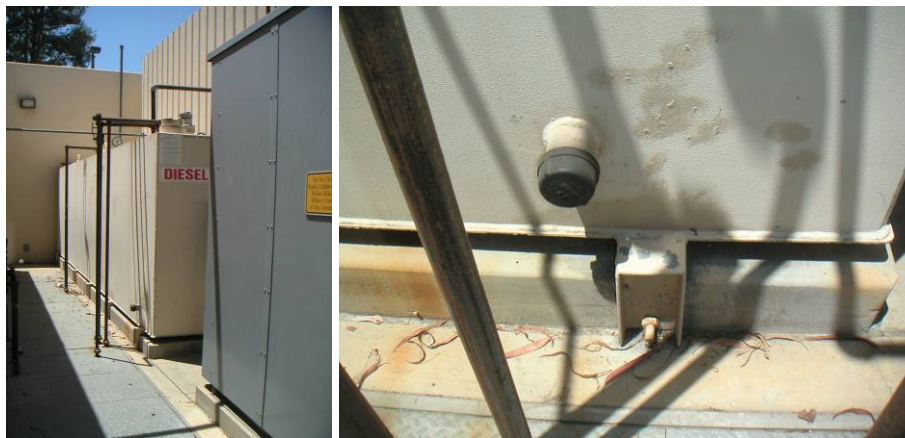
Figure 3-46. DPF generator's fuel tank and its seismic restraint

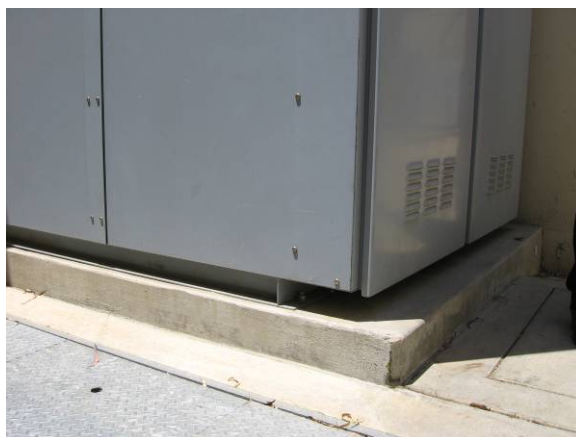
Figure 3-47. Seismic restraint of DPF generator's switchgear

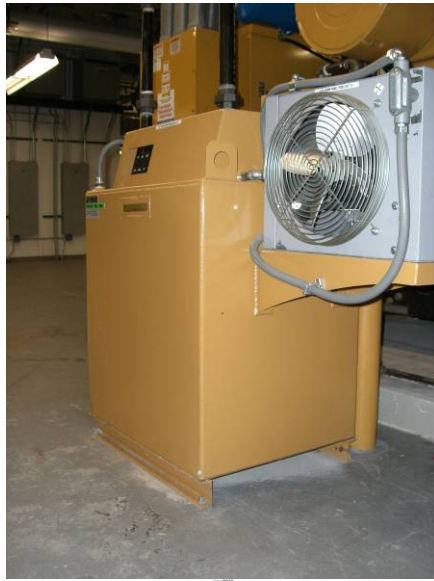
Figure 3-51. BDF generator day tank and electric fuel pump, apparently anchored to the slab

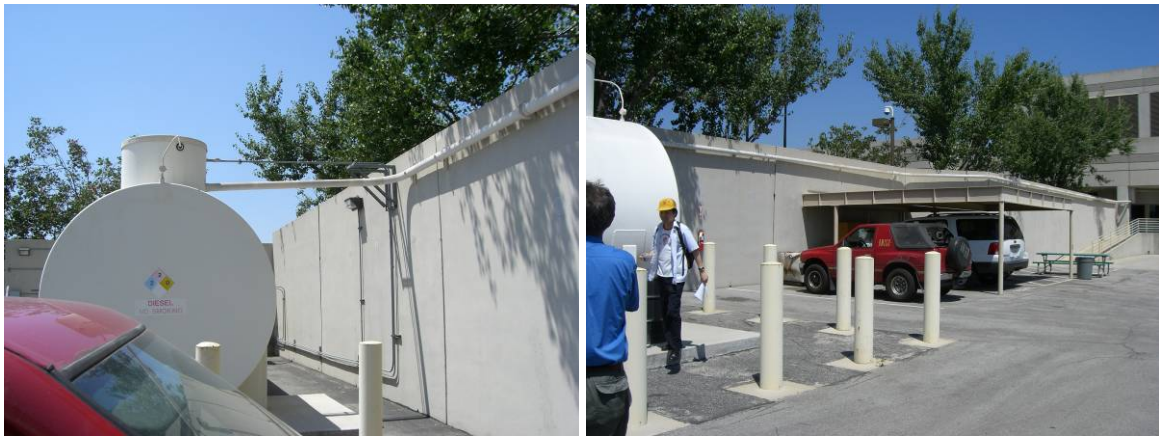
Each generator has a 50-gal day tank and we were told burns approximately 110 gal/hr. A 20,000 gal fuel tank outside the building and anchored to its plinth (Figure 3-53) therefore provides up to 180 hr (8 days) of fuel. The fuel pump is inside the tank. We observed that the supply pipe that runs between the tank and the generators is secured along about 125 ft to a heavy concrete fence comprising seven panels with no connection between them (Figure 3-54). Differential displacement of the tops of these panels could conceivably rupture the supply pipe, both disrupting on-site power generation and causing a hazardous material spill. In that event the generator could possibly be supplied by manually filling 55-gallon drums (one was observed next to the tank) and hauling them up to the generator day tanks. An alternative approach would be to provide a shutoff valve on the pipe run from the tank and an alternative point for injecting fuel into the supply pipe from a tanker parked at the loading

dock, where the pipe enters the building (Figure 3-55). Failure of the diesel supply pipe along this fence may represent an important weak link at this facility.

Figure 3-54. Fuel line secured to a long segment of concrete fence at BDF

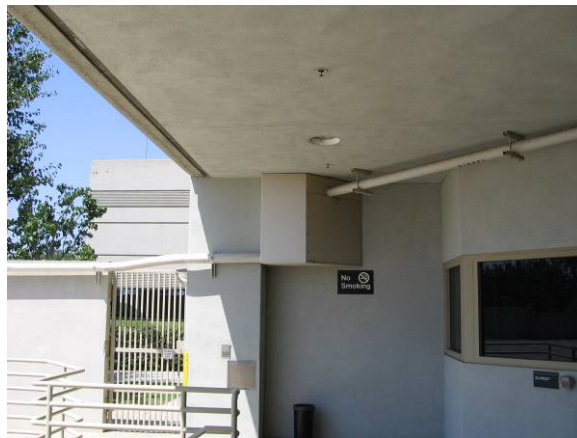
Figure 3-55. Possible access point on the loading dock for alternative method of fueling diesel generators in case the fuel pipe breaks on the concrete fence

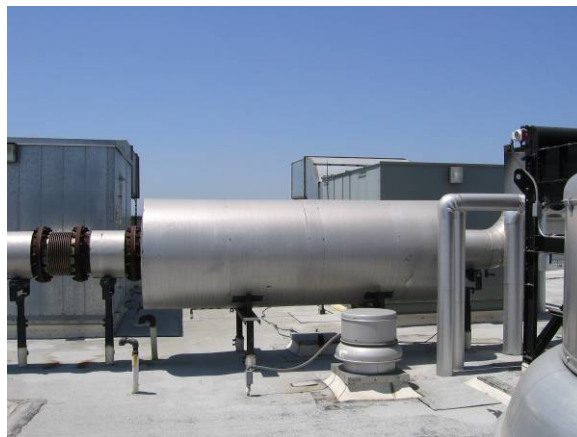
Near the generators is synchronizing gear, which ensures identical phase and voltage from the generators. The gear appears to be anchored to the slab. On the roof above, each generator has a radiator whose anchorage was not visible (Figure 3-56), muffler that appeared

to lack positive seismic restraint (Figure 3-57) and an enclosure containing air intake fan with equipment to cool the outside air before it is fed into the generator (Figure 3-58). The intake fan motor had vibration isolators with questionable resistance to lateral displacement. The lack of seismic restraint for the mufflers is presumably not a critical issue, as long as local authorities would allow the generators to be run despite damage to the mufflers. Damage to the air intake fans could conceivably prevent the generators from operating, so the light vibration isolators might be more of a reliability issue.

Figure 3-57. Muffler for BDF emergency generator

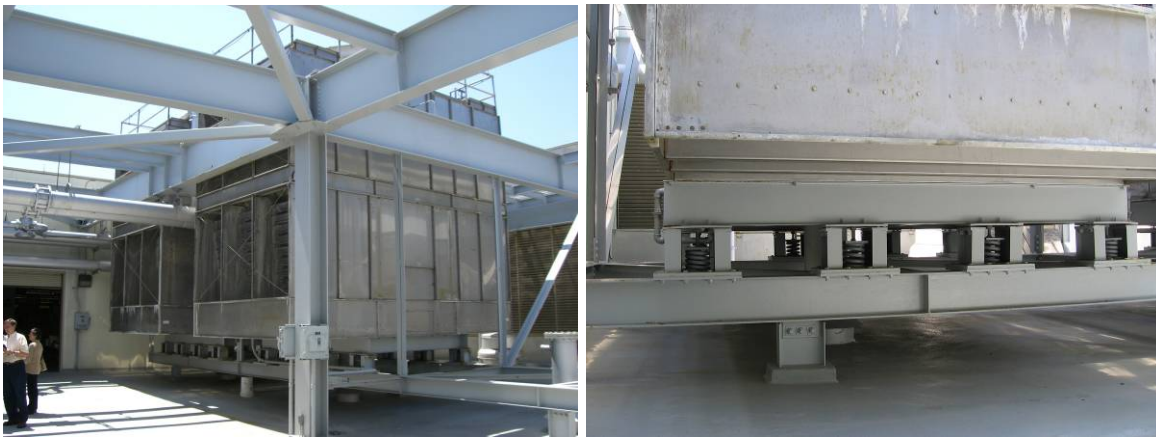
Cooling towers. There are two 1000-ton cooling towers at the facility with isolators that provide resistance to uplift and lateral displacement (Figure 3-59). There are two 30,000-gal water storage basins, each with three redundant pumps anchored to the floor (Figure 3-60). The cooling towers lose up to 500 gal/hr to evaporation, so if off-site water supply were lost, the basins could supply at least 60 hr of water for cooling. The basins can be refilled from trucks outside the facility.

Figure 3-59. BDF cooling towers and their anchorage

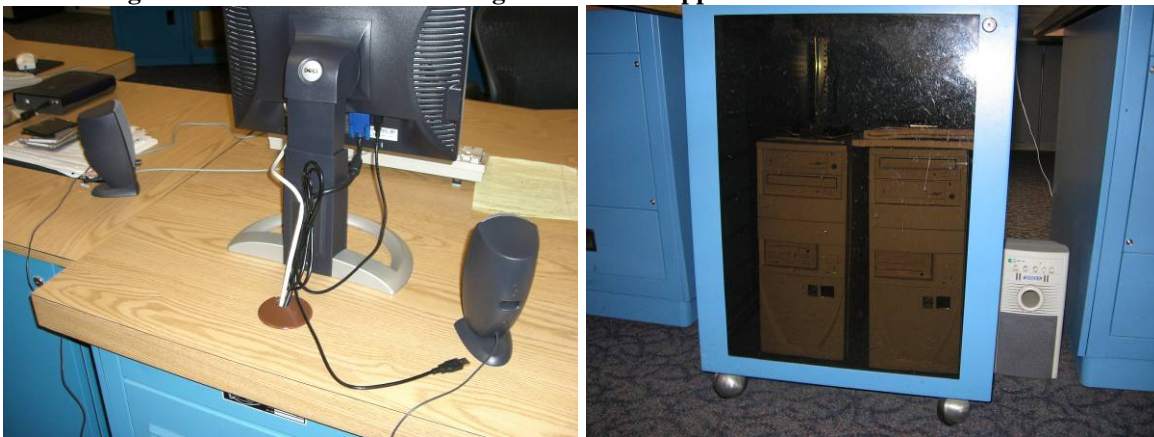
monitors are not secured and at least some system units were in unrestrained cabinets (Figure 3-66). Suspended ceilings in this room appeared to have compression struts and diagonal splay wires, but not in the same places as would be required for modern construction (Figure 3-67). The ceiling is captured all the way around by walls, which tend to be more remediate this problem. However, ductwork and automatic sprinkler lines appeared largely to lack lateral restraint that would help to mitigate the potential for seismic damage (Figure 3-68). An equipment closet in this room contains approximately 20 non-redundant DDC panels fastened to the wall (Figure 3-69). Of some concern is the fact that this closet has automatic sprinklers rather than Halon. If the sprinkler pipe were damaged or water were otherwise discharged, it could conceivably damage all these panels. Although building engineers informed us that all the building service equipment can be run manually, the ceiling system in the control center, the sprinklers in this equipment closet, and the lack of seismic restraint for the computers in this room may represent important weak links at this facility.

Figure 3-66. Some computer equipment in BDF building control room lack seismic restraint

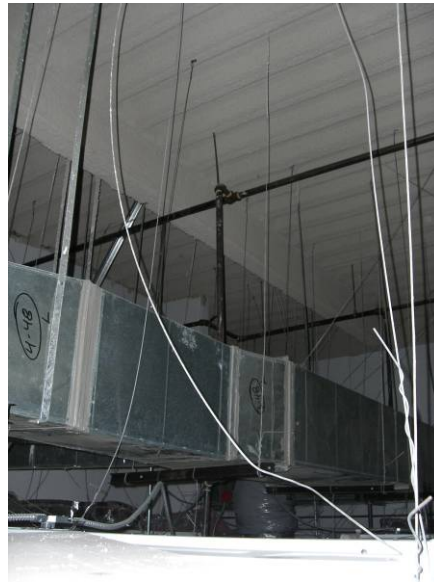
Figure 3-68. Ductwork and automatic sprinkler lines in BDF building control room appeared largely to lack lateral restraint.

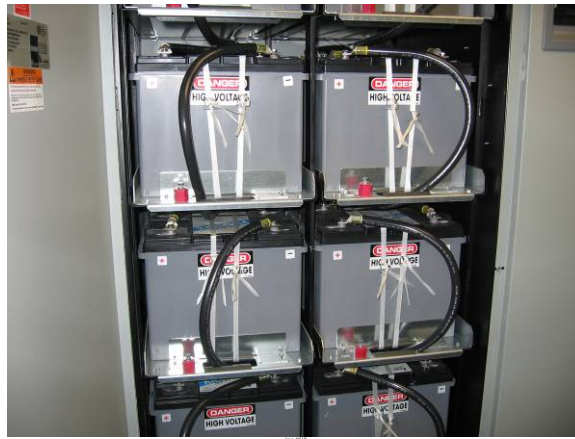
UPS equipment. We observed four battery modules, with three cabinets per module, all apparently anchored to the slab (Figure 3-71). Batteries for the most part appeared to be secured to their racks (Figure 3-72). We did not observe whether the batteries have spacers, but as the image shows, conductors between batteries appeared to be flexible cable and thus less subject to fracture in case the batteries pound into each other inside the cabinet. We observed a (non-critical) battery charging rack without apparent anchorage (Figure 3-73). Two redundant systems of two uninterruptible power modules per system (rectifier, inverter, etc.) appeared to be anchored to the slab (Figure 3-74). Air conditioning equipment near the UPS systems appeared to be anchored to the slab (Figure 3-75).

Figure 3-72. UPS batteries at BDF

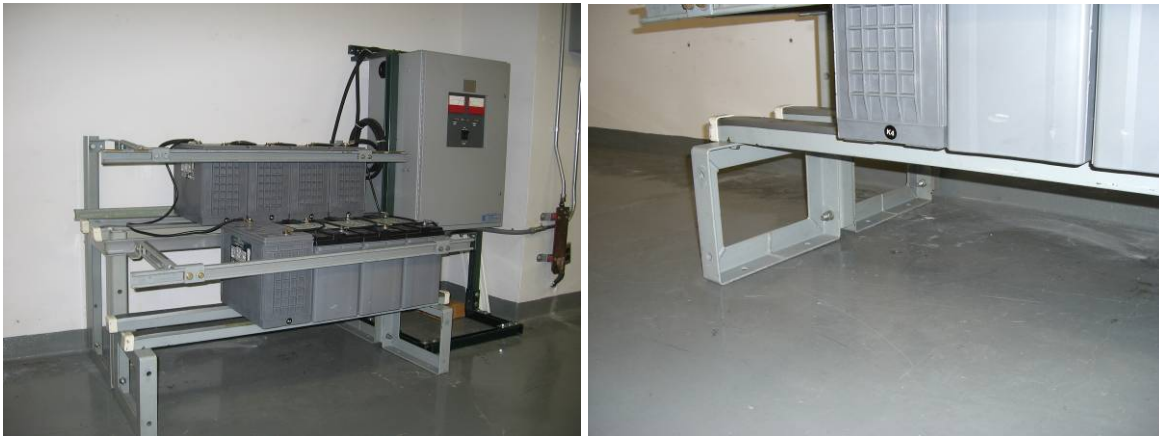
Figure 3-73. Non-critical battery charging rack at BDF without apparent anchorage to the floor

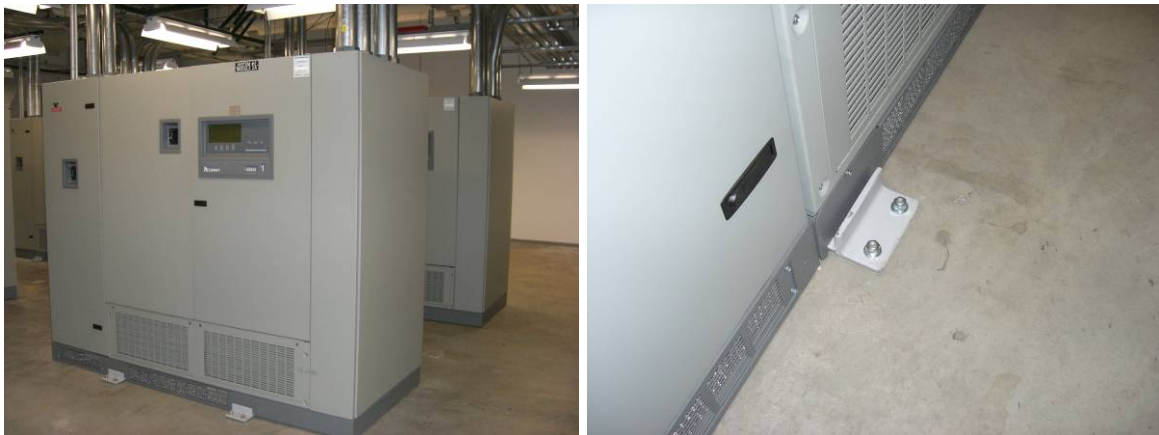
Figure 3-74. UPS equipment at BDF apparently anchored to the floor slab

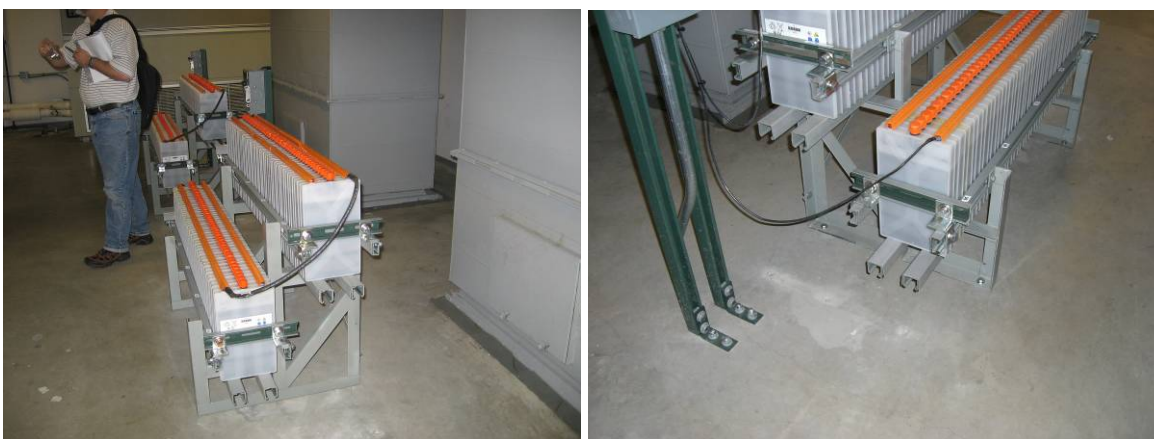
Switchgear room. We observed two long panels of switchgear, all apparently anchored to the concrete plinth (Figure 3-78), and two racks of batteries to power these, also anchored to the slab and having longitudinal bracing and no need for battery spacers (Figure 3-79).

Figure 3-79. Battery racks, apparently well anchored, with restrained batteries and longitudinal braces

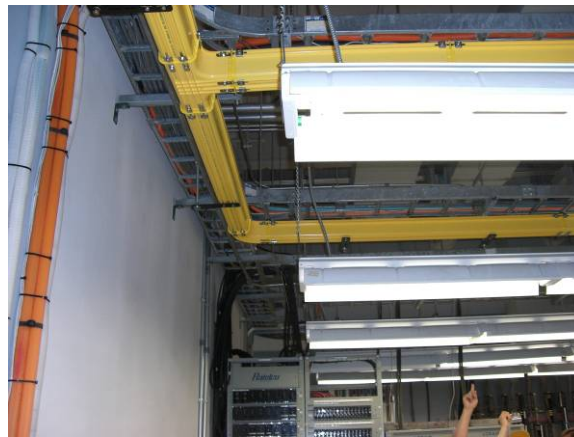
Figure 3-81. Overhead cable trays in BDF telecommunications room appeared to be braced to the wall

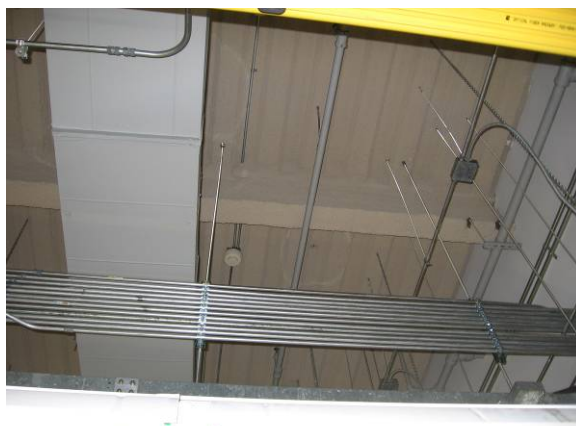
Figure 3-82. Long unbraced runs of sprinkler pipe in BDF telecommunications room

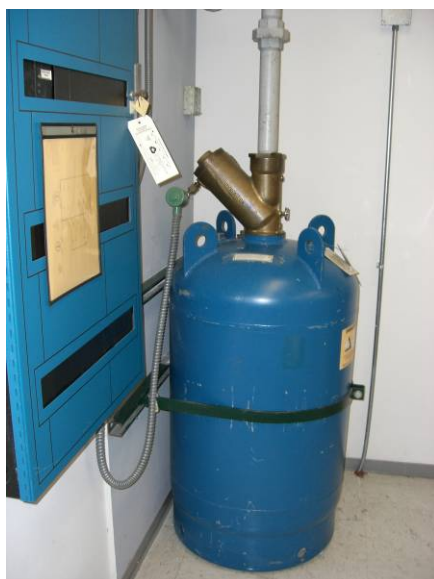
Figure 3-83. Halon tank in BDF telecommunications room, apparently strapped to the wall

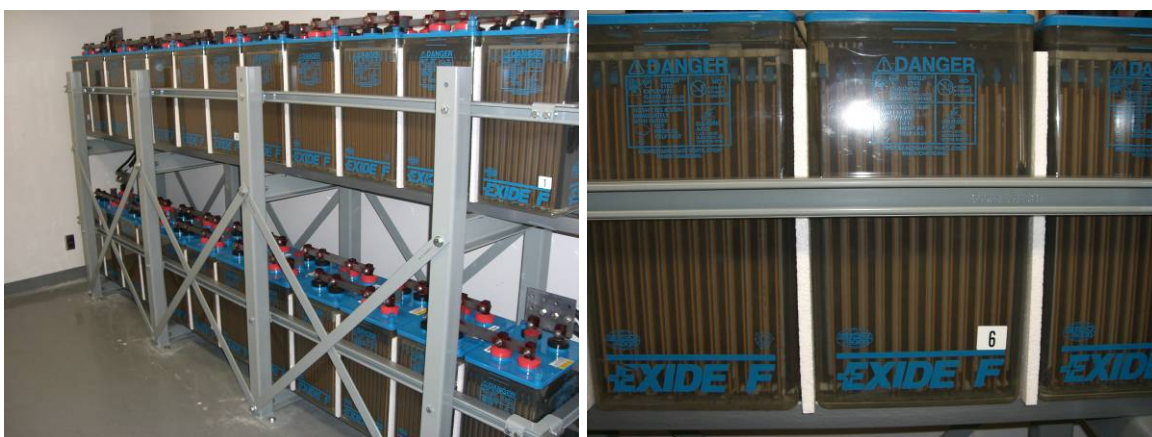
telecommunication equipment appeared to be secured to the floor slab (Figure 3-80). Overhead cable trays appeared to be braced to the wall (Figure 3-81). The room is protected by automatic sprinklers as well as a Halon system, although building engineers informed us that the Halon system should suppress any fire and prevent the fusible links on the automatic sprinklers from melting and causing water to discharge, although as elsewhere long unbraced runs of pipe (Figure 3-82) raise increase the probability of earthquake sprinkler leakage. The Halon tank appeared to be secured to the wall (Figure 3-83). The telecommunications switching equipment has its own battery rack, anchored to the slab, with longitudinal braces and battery restraints and spacers, all desirable features for seismic resistance (Figure 3-84).

Figure 3-84. Battery rack for telecommunications equipment

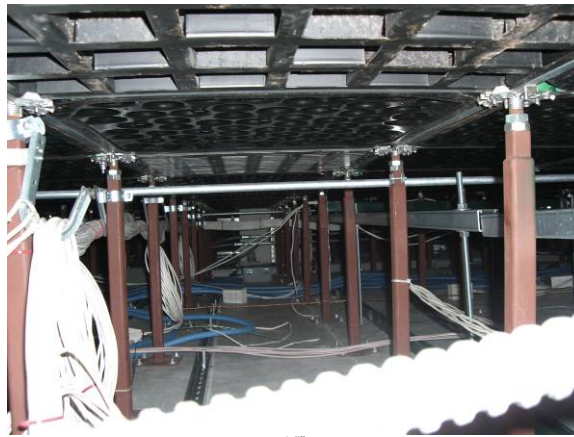
CPU room. This large room stands on 2-ft raised access flooring. The pedestals within sight of our vantage point lack diagonal bracing, and were anchored at four corners with epoxy anchors (Figure 3-86). Equipment in this room is restrained by various systems, for example, bolted to IBM anti-tip plates in front and an innovative angle bracket to a rear wheel axle. These are then secured to a steel cable tether, with turnbuckle to adjust for tautness, itself secured to a Unistrut member secured to the slab below (Figure 3-87). We were told that all equipment in this room weighing in excess of 400 lb is tethered in this fashion. Lighter equipment is secured against overturning by threaded rods secured to the levelers and anchored to the slab below, as at DPF. It is conceivable that the tethers on the larger equipment could act to restrain the raised access floor in the absence of diagonal braces, but because the tethers are not taut, and are not designed to restrain the floor, the raised access flooring is more likely to collapse than if diagonal braces were present. Unbraced raised access flooring could be an important weak link at this facility.

Figure 3-86. Raised access floors at BDF CPU room, apparently lacking braces

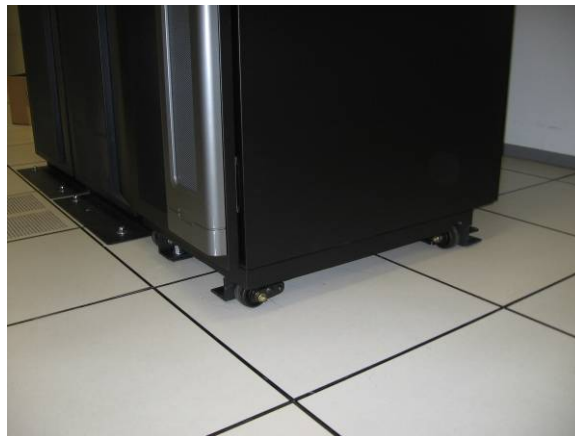
Tape silo room. Similar to the data processing facility, four cylindrical tape silos in the backup data facility rest on 12-in raised access floor. While some controllers appeared to be seismically restrained (Figure 3-91), the cylindrical silos themselves are not, and are therefore more likely to slide, pound against each other, and possibly become inoperative in an earthquake (Figure 3-92). This may be an important weak link at this facility.

Figure 3-91. Seismic restraint of controllers in BDF tape silo room

most effective mitigation measure for this facility would be to mitigate the tape silos, either by seismic restraint (if that is possible for these pieces of equipment) or by relocating them at a seismically stable location. If the tape silos could be made seismically rugged, doing so would increase to 0.33g the *PGA* at which failure is more likely than not. By strengthening all components identified here as possible weak links, the *PGA* associated with 50% failure probability is increased to 0.85g. Note that we have assumed that damage to the tape silos is perfectly correlated—if one fails, all fail, which we deem reasonable given their proximity. See Figure 4-1b.

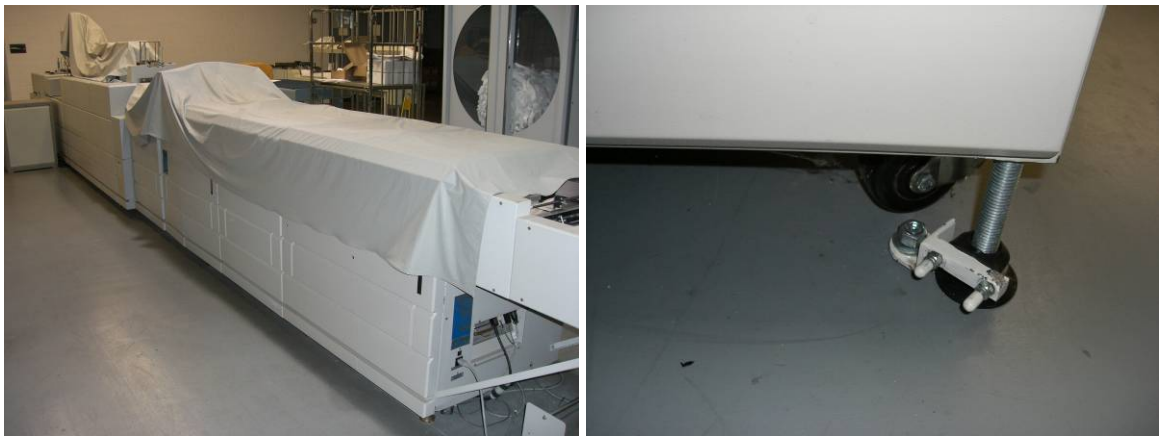
Figure 3-94. Restraint of document handling equipment in BDF

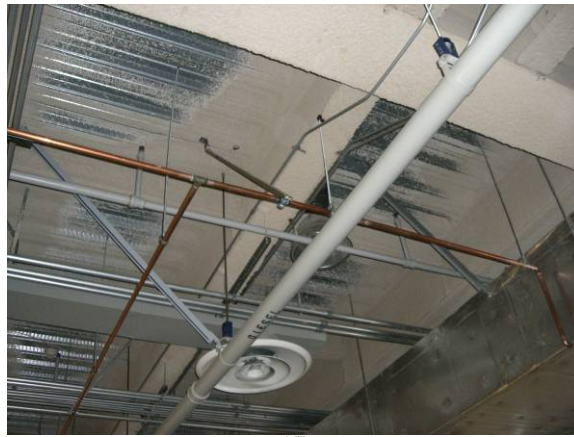
Figure 3-95. Long unbraced lengths of sprinkler pipe and minimally braced copper air pipe in BDF

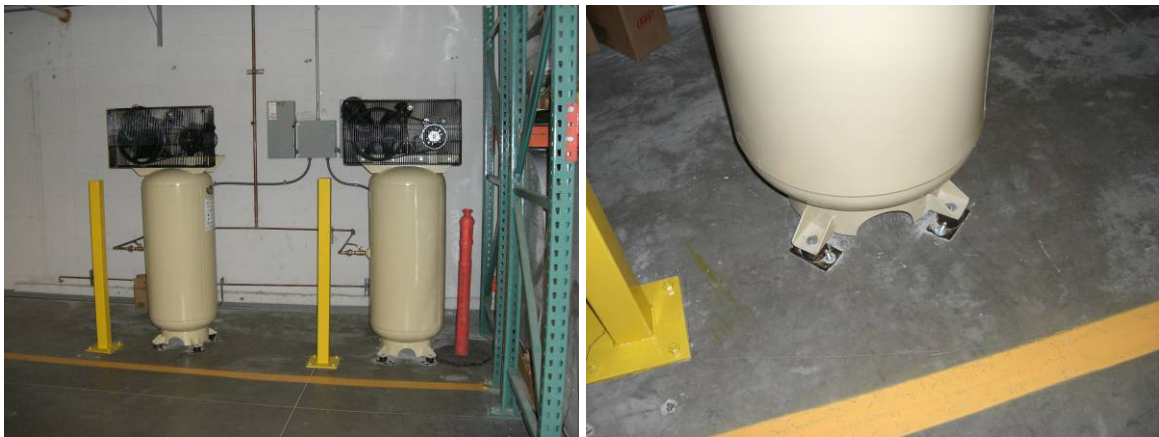
Figure 3-96. Anchorage of air tanks and compressor assemblies in BDF

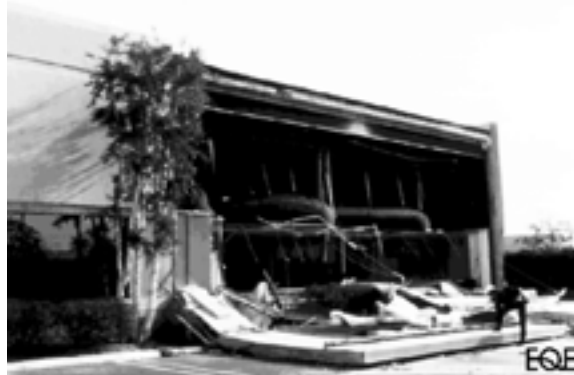
Several new business parks throughout the San Fernando Valley were severely damaged. One business park had extensive structural damage to all of its roughly one dozen buildings. The two-story structures were steel framed and were enclosed with two-story-high, reinforced concrete, precast tilt-up panels. The first-floor sections of the tilt-up panels failed, and finished elements of the building interiors were extensively damaged [see Figure 3-98 and Figure 3-99]. Prior to the earthquake, the buildings housed computer centers and other service operations. One week after the earthquake, most of the buildings had been completely evacuated.

Figure 3-98. Damage to tilt-up construction during the Northridge earthquake – this section of tilt-up wall pulled away from the rest of this high-technology company’s corporate computer center. There was severe damage to the interior as a result. Source: EQE International (1994).

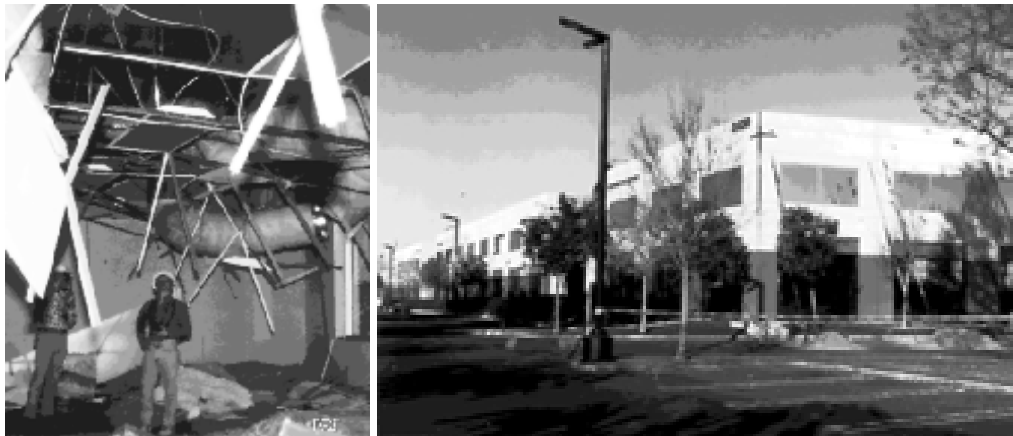
Figure 3-99. Damage to tilt-up construction during the Northridge earthquake – The wall of this office tilt-up nearly fell away during the earthquake. It has been braced, and a temporary tie to the adjoining wall has been installed until more permanent repair can be made. The interior of the second floor was almost completely destroyed (as shown in the photograph on the left). Source: EQE International (1994).

There are many such instances of the poor performance of precast tilt-up construction during earthquakes and for a critical facility, a more robust and ductile structural system should be in place.
